The University of New Mexico

ATR Institute

October 27, 2003

At your request I accompanied you to the **St. Vrain Mill located in Mora, New Mexico** for a condition inspection on May 22, 2003. The purpose was to perform a condition inspection to aid in an evaluation of the existing structure. The purpose of this report is to describe the conditions observed and propose measures that will be required to fully evaluate the structure and outline rehabilitation options that may be considered for future implementation.

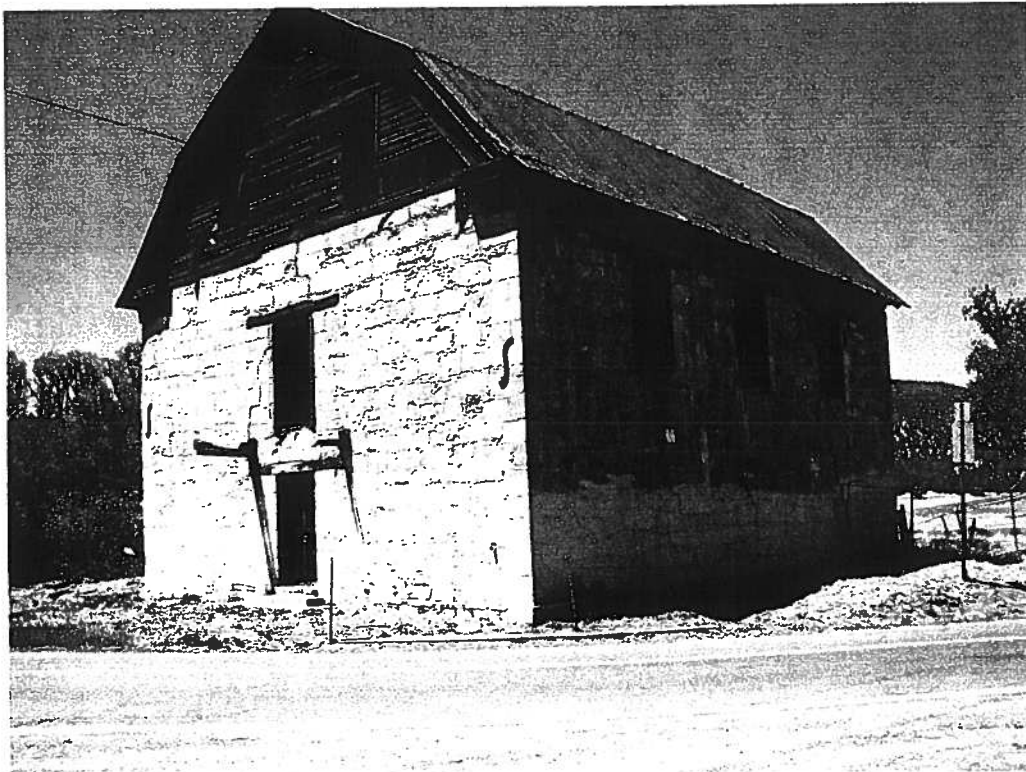
Photo 1 Looking at the southwest corner from across State Road 434 [5/22/03].

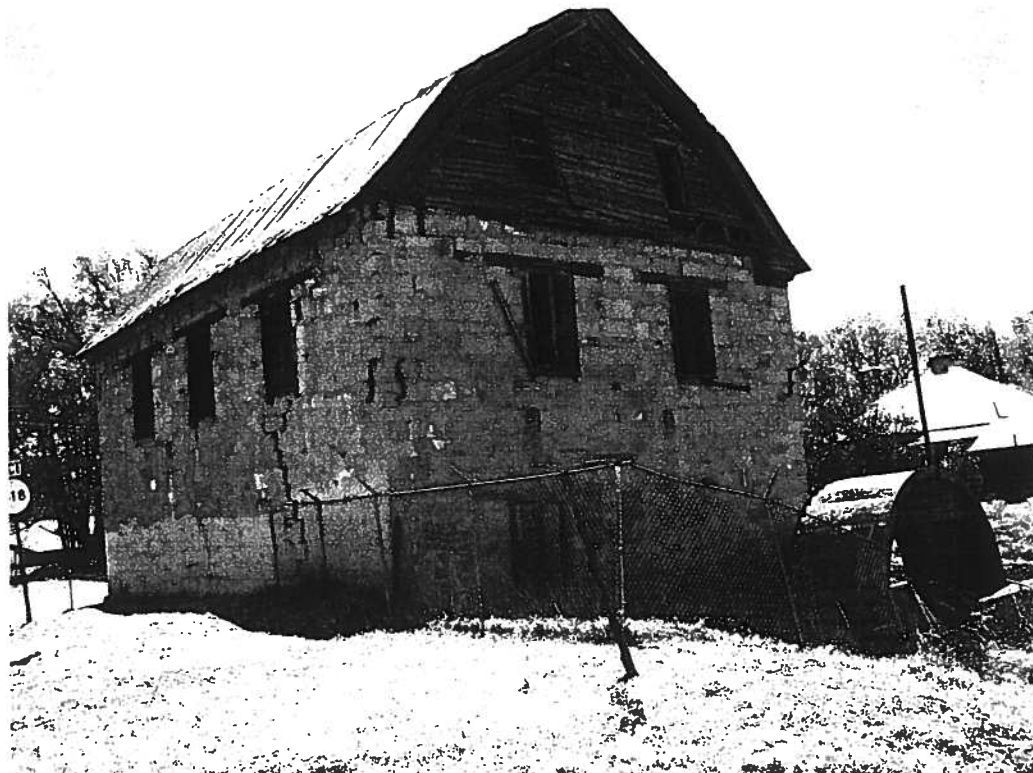
The roof is a hipped structure made of 5x5 inch members 24 inches on center and covered with spaced 1 x 8 inch sheathing in turn covered with corrugated metal. Photo 2 shows an overall exterior view of the roof structure. Photo 11 shows the rafters, roof sheathing and metal roof between the sheathing. Some deterioration of the rafters is apparent due to moisture penetration although this is isolated. In general the roof framing and sheathing are in good condition based on visual inspection. Those areas that are deteriorated must be carefully inspected and the need for some replacement of components is expected. The area that is most likely is at the hip point of the roof, apparently due to water leaks in this part of the roof.

Photo 2. East end of the building and the water wheel [5/22/03].

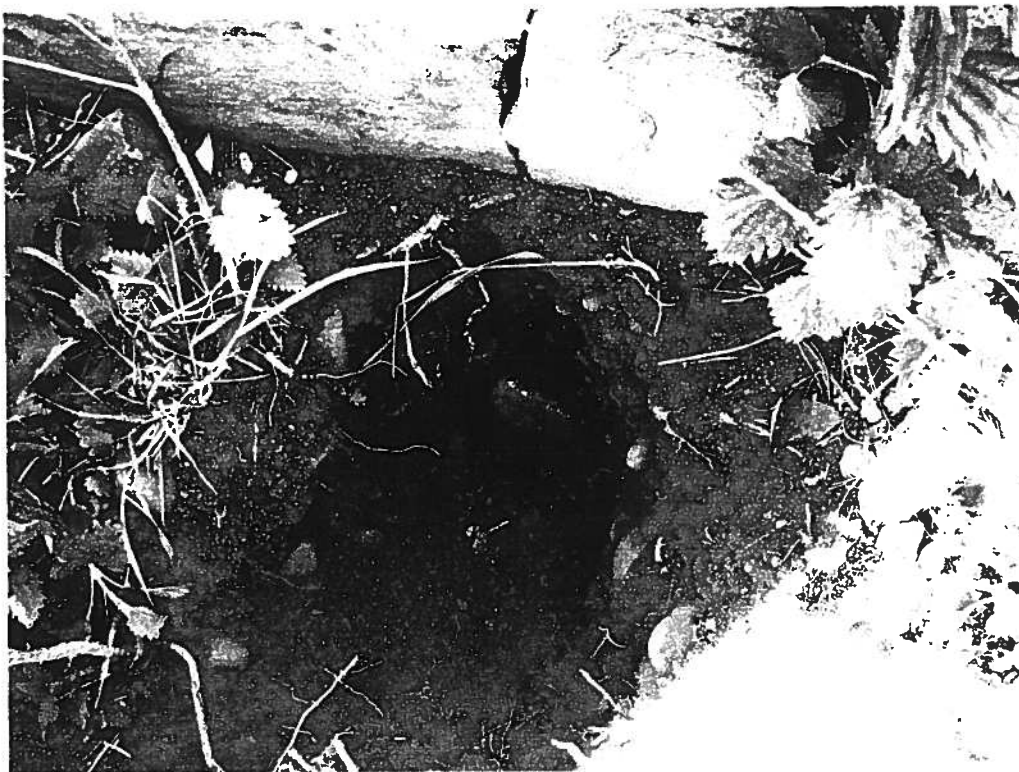
The block walls are supported on stone foundations formed by excavating a shallow trench and placing rock in the trench. Photo 3 shows an excavation made at the northeast corner of the building to expose the rock foundation. Soils are sandy silt based on visual-manual examination. No soil sampling or testing was performed as part of this investigation.

Photo 3 shows the foundation for the rock walls is a shallow stone foundation. This excavation was made at the northeast corner to reveal the depth and nature of the foundation. Stone foundations were made by excavating a shallow trench into the site soils, placing stones, then placing the wall structure on the stones. Based on the limited excavation it appears to accurately describe the foundation for the mill. The foundation has performed well except on the east end of the building. That area exhibits relative movement that indicates the east wall has settled several inches and rotated outward from the building. As a result of settlement the north and south walls are severely cracked near the East end. Based on my visual inspection it is my opinion this distress occurred long ago has been stable for some time. Photos 4 and 12 show cracking on the South wall due to settlement of the East wall. Photos 5 and 6 show separations at the East end of the North wall due to settlement of the East wall of the building. Two factors have contributed to the distress on this end of the structure. First, the water wheel and therefore a source of water were located close to the south end. Water may have affected the soils contributing to loss of support. Second, the working machinery for the mill was concentrated at this end of the facility. Machine vibrations may have been transferred to the wall structure and caused wall settlement.

Photo 3. Foundation made of stones placed in a shallow trench [5/22/03].

A stability analysis of the wall should be completed to evaluate whether it is in danger of collapse. Based on the visual analysis it appears the wall is severely distorted but stable. However, the distortion of the wall is severe enough that repairs must be made, even if it is found to be stable, in order to correct the displacement of the wall components, especially on the third floor.

Repairs may be accomplished by underpinning the rock blocks forming the wall. Since there is no foundation structure beneath the rock a beam structure of sort must be installed beneath the rock blocks to distribute loads over several blocks so the wall can be lifted. Once the beam is in place piers may be installed to jack against for lifting the wall back near its original position. The likely type of pier for this purpose is a steel shaft helical pier that is installed by using torque to screw the helical plates into the ground. Because of the heavy loads involved, an engineering analysis will be required to establish the pier spacing, type of plates and verify the capacity. Some framing will also be required to maintain stability of the wall during the repair process.

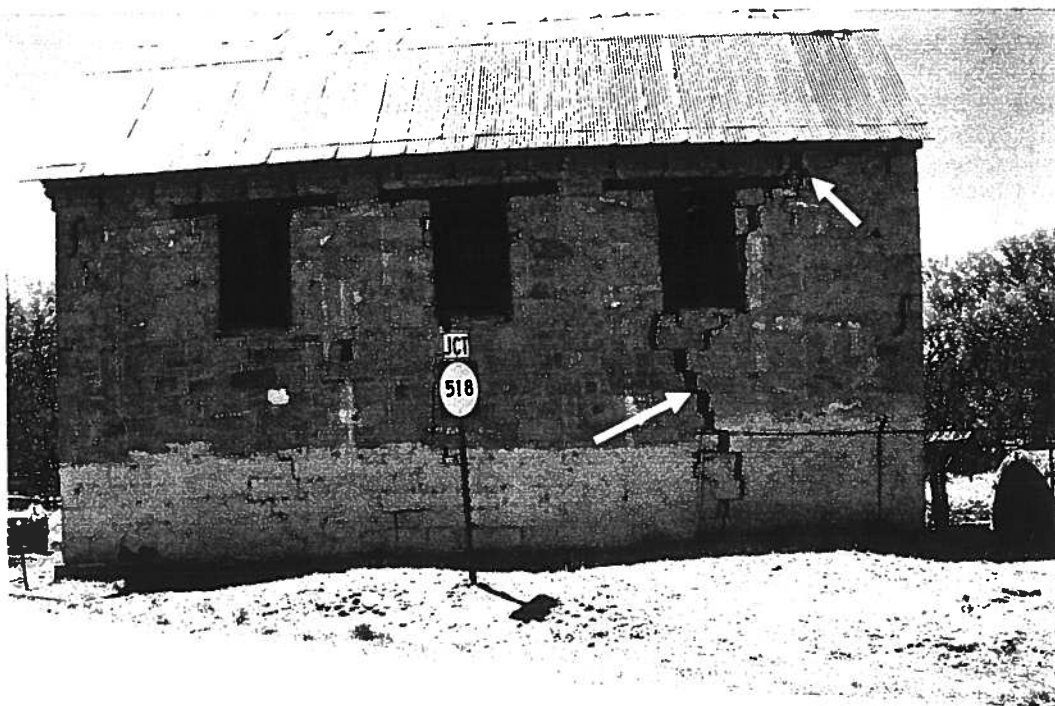
Two major distresses are apparent based on visual inspection. The first is the east wall has moved down relative the remainder of the building, probably due to soil settlement, long ago. This has produced rotation of wall outward causing major separations in the stone wall on the south side, Photo 4 and the north side, Photos 5 and 6. The wood structure across the east end under the roof is bowed outward. The second major distress is the rotting of wood lintel beams over the window openings. Photo 6 shows the second floor window on the east end of the north wall, where the lintel is completely missing over the upper level window. All of the lintels are rotted to some extent and will have to be replaced to support the rock wall components above.

Photo 4. Wall separation on the south east side of the building [5/22/03].

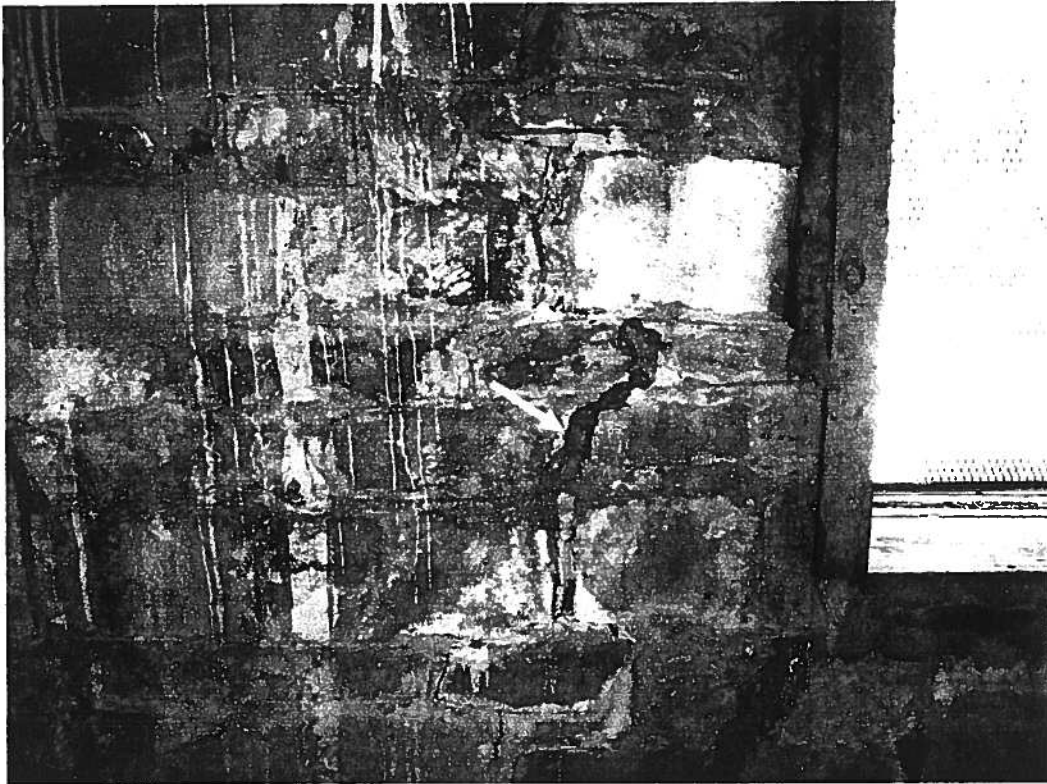
Photo 5. Wall cracking on the northeast side of the building [5/22/03].

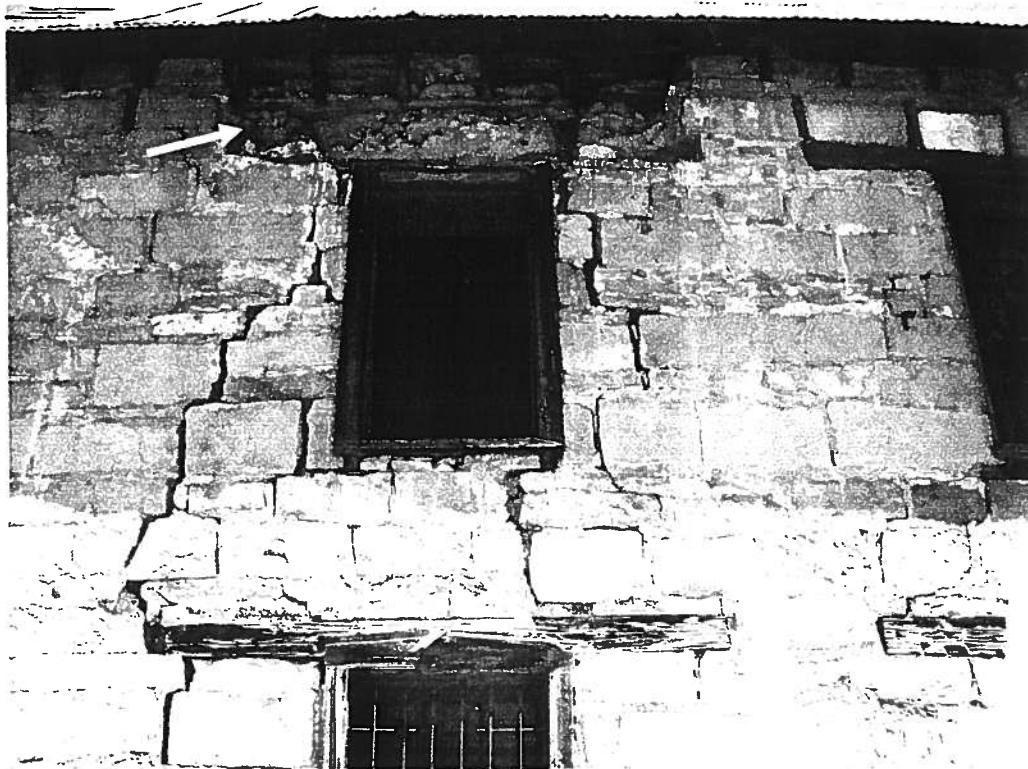
Lintels over the windows are rotted badly and have deteriorated to the point that most will require replacement. Photo 6 shows one lintel on the North side is missing completely. Some of the stone masonry supported by the lintels has also been damaged due to loss of support from the lintels. Each of the lintels must be carefully inspected and sampled or tested for condition to determine whether or not they are serviceable and may remain in place.

Photo 6. Lintel beams are rotted and missing on the north wall [5/22/03].

Lintels over the window openings are rotted and most will have to be replaced. Some stone wall components over the windows have been damaged and some repair to these areas is necessary. Re-pointing of mortar around the building is needed.

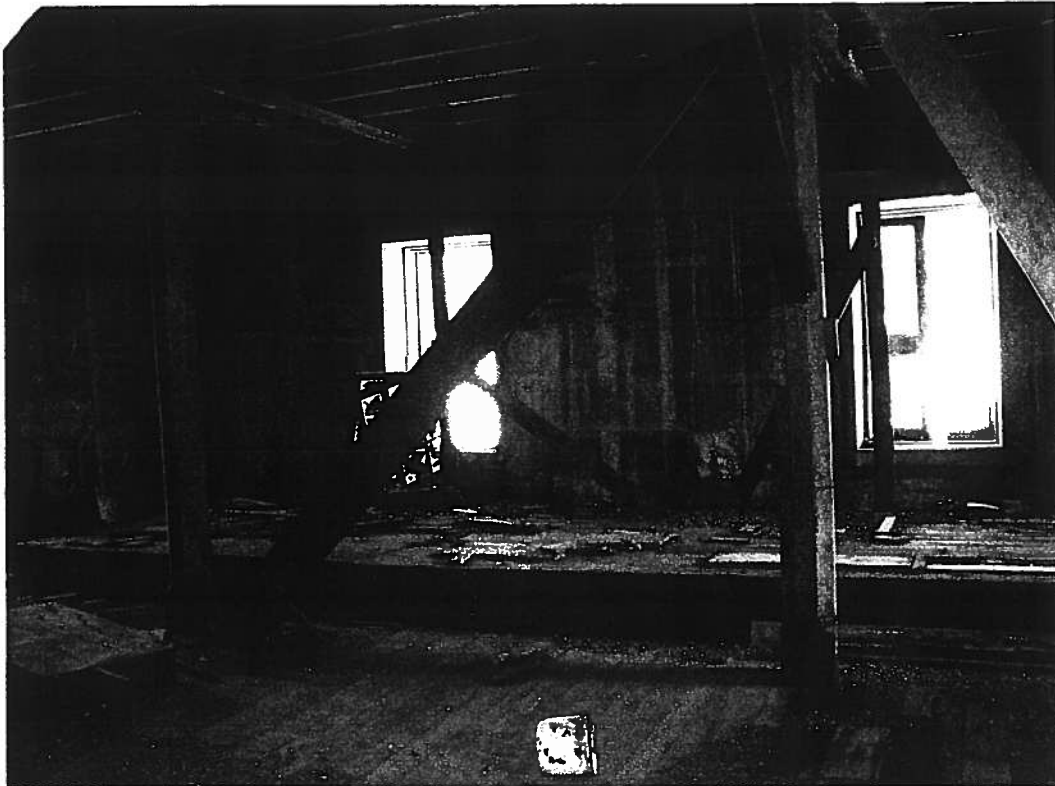
In general the wood framing on the interior is in good condition. The building is supported on load bearing stone walls and interior wood columns that support girders running north/south. Floor joists are supported on the girders and run east/west with flooring supported directly on the joists. All of these members are in good condition except as described below. The wood is rough sawn and does not comply with modern lumber sizing. The dimensions vary depending on the specific structural member and in numerous cases connections are made by cutting notches into the connecting members to form a socket. These connections will require careful inspection to develop a basis for structural analysis because the member cross sections are reduced. Based on visual inspection there is no apparent distress associated with these types of member connections. Photos 7(**P9**) and 8 (**P20**) illustrate the framing of the second and third floor. Photo 7 shows the second floor columns supporting the third floor framing. Photo 8 shows the second floor joists notched into the girder supporting the floor.

Photo 7. Second floor columns supporting third floor structure [5/22/03].

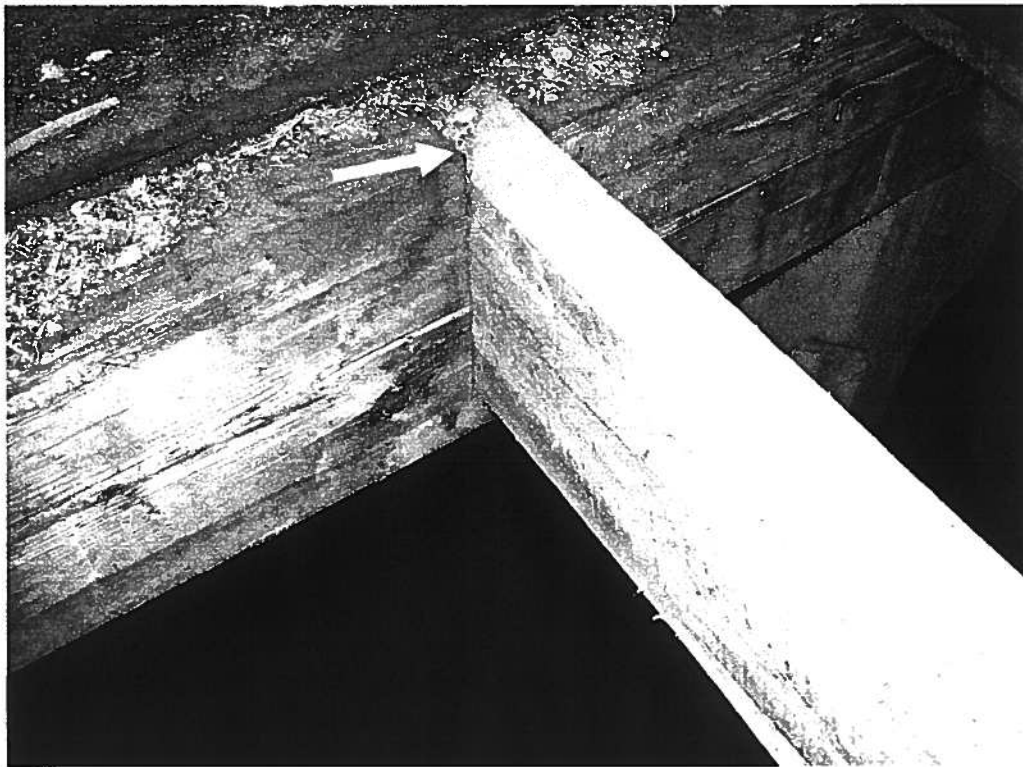
Photo 8. Notched connection of framing for floor support [5/22/03].

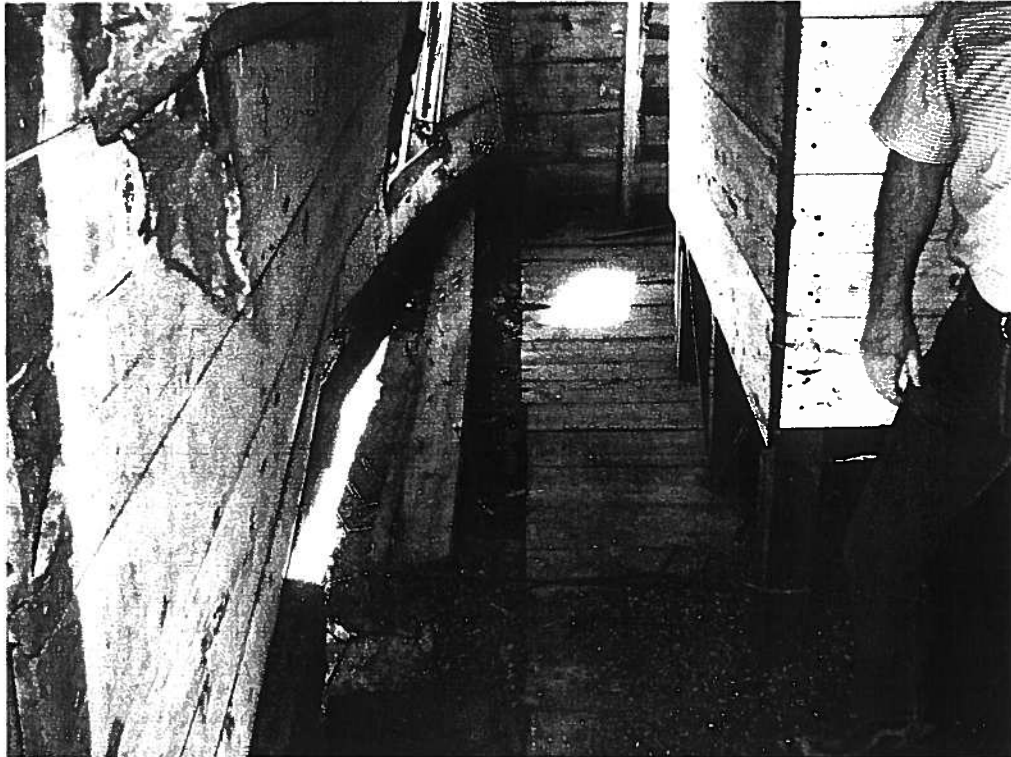
Based on visual inspection there is no evidence of load related distress in any of the framing members that were accessible or inspection. The third floor wall beneath the roof enclosing the east end of the building is bowed outward due to rotation of the east wall resulting in rotation of the wall outward. Photo 9 shows the wood structure that is bowed outward on the third floor due to the wall settlement and rotation. Photo 10 shows the stone wall east end beneath the third floor where the wall has moved out from under the framing. This is the area where the foundation has set the third floor that has moved outward. This movement is also the result of rotation of the east stone wall of the building.

Photo 9. Third floor end all bowed out due to wall settlement and rotation [5/22/03].

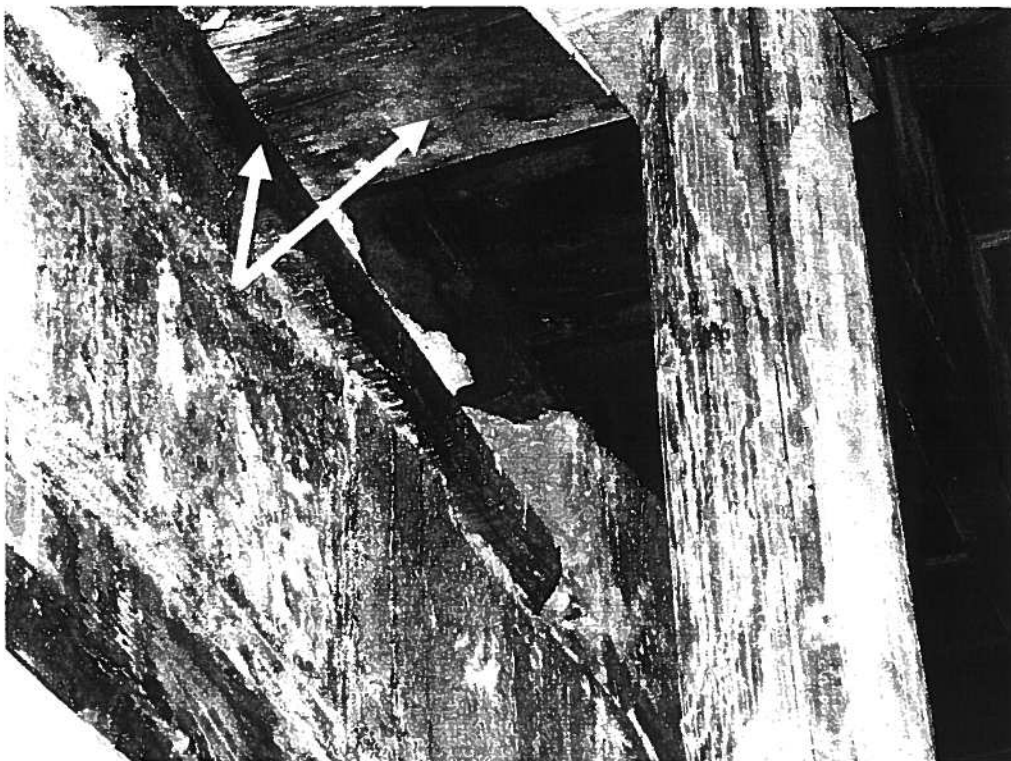
Photo 10. The East wall has moved out from under the framing [5/22/03].

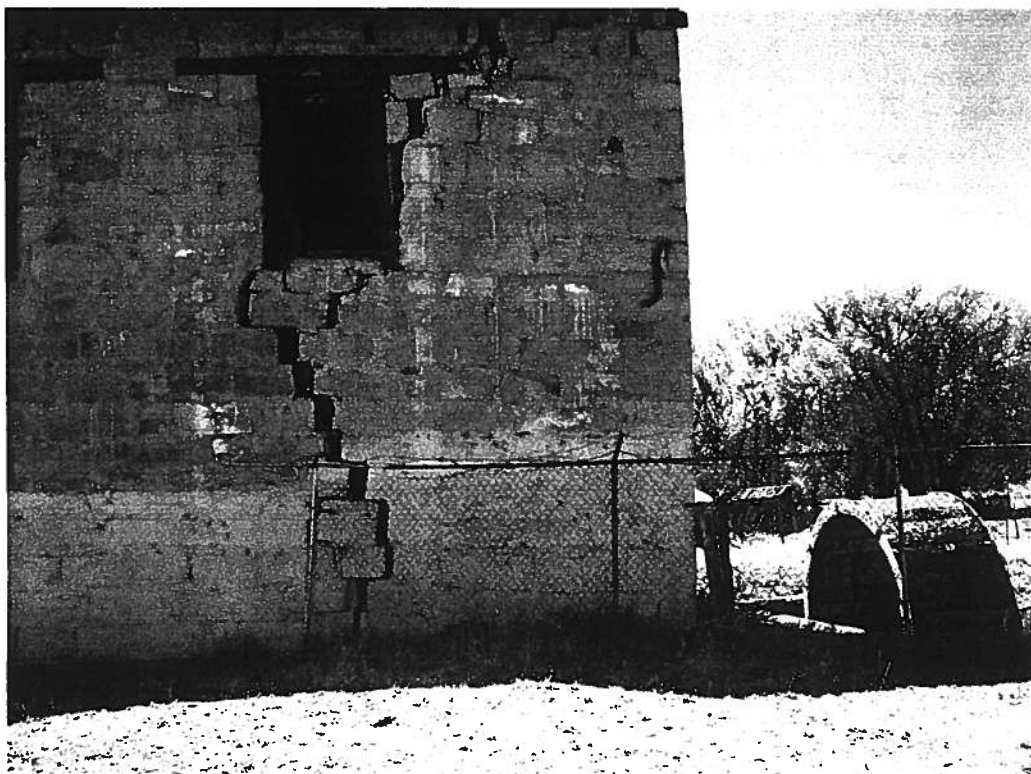
Cracks are apparent around the building on all sides. The most dramatic distress is the East end of the structure discussed above. The rock at the top along the north side has deteriorated at several of the lintels and must be repaired once the lintels have been replaced. Throughout the building a complete inspection of the rock and re-pointing of the mortar is a minimum requirement. Some areas will require removal and replacement of portions of the stone wall, such as the east end of the south wall.

Photo 12. Stone cracking on the East end of the south wall [5/22/03]
