**SAINT VRAIN MILL**

**MORA, NEW MEXICO**

**HISTORIC STRUCTURE REPORT**

**SEPTEMBER 2015**

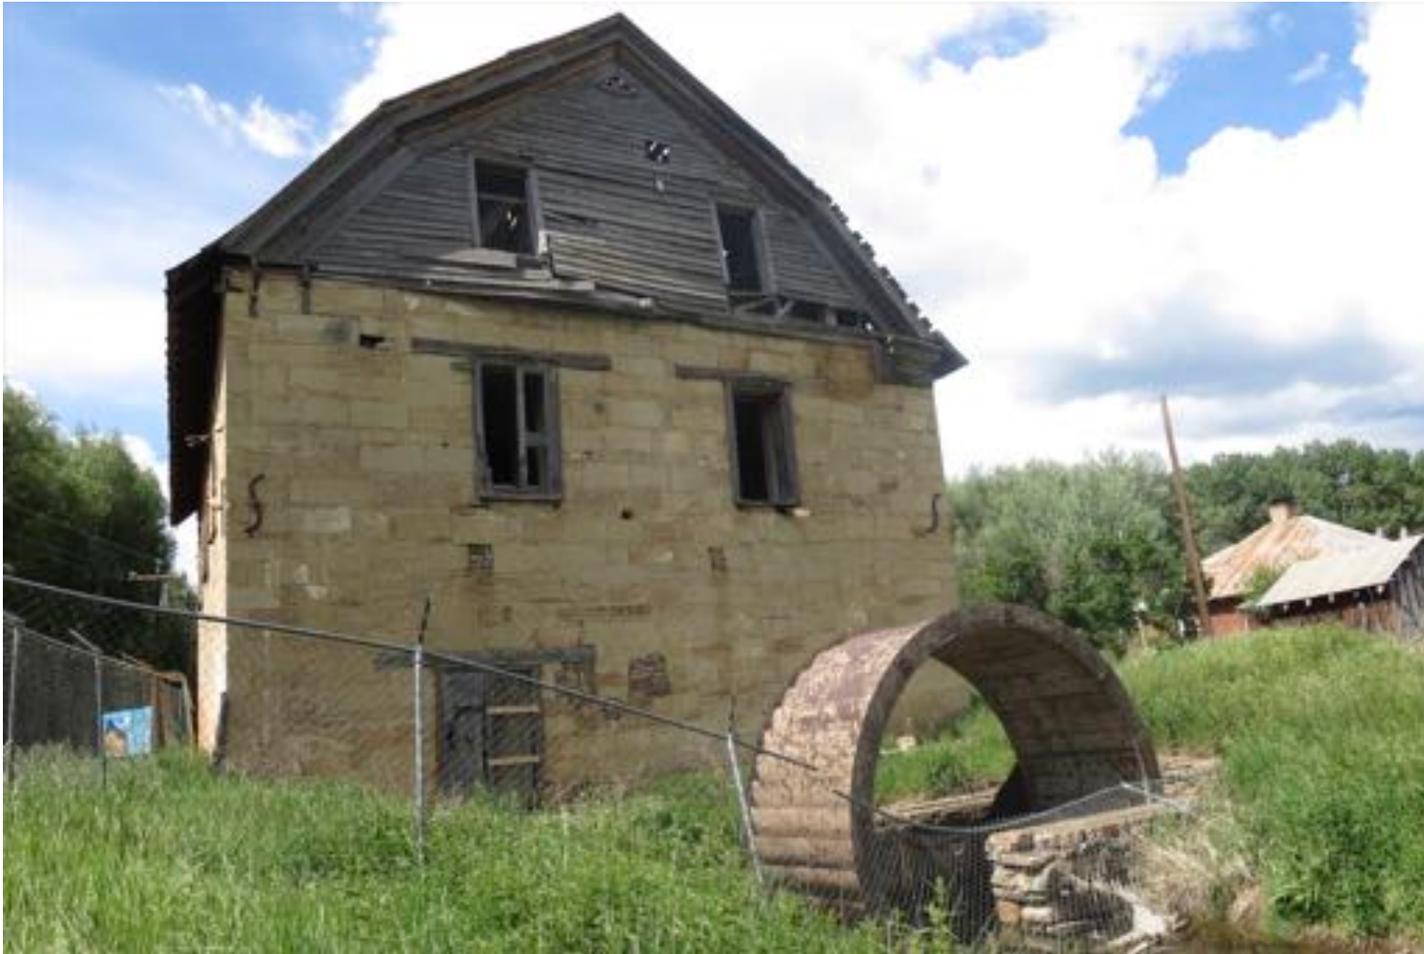
The exterior wood clapboard siding at the north and south gables is extremely weathered and in a deteriorated condition. There are some areas where the siding has fallen off of the building. The north wood frame end wall is bowed (to the exterior) and is partially detached from the stone wall below.

North façade showing bowed gable framing and eave deterioration. 9 June 2015

The other urgent matter is the repair of the roof of the mill. The northwest corner of the mill roof is missing. This could be given a temporary patch. Complicating the matter is the partially loose and bowed north frame gable. The north gable framing needs to be rebuilt or at least rehabilitated after the stone walls beneath it are stabilized. The north gable framing should ideally happen prior to permanent roofing because this work will certainly disturb the roofing at the north end of the building. It might be that the roof could be adequately braced and shored while the north gable is rebuilt but this seems questionable.

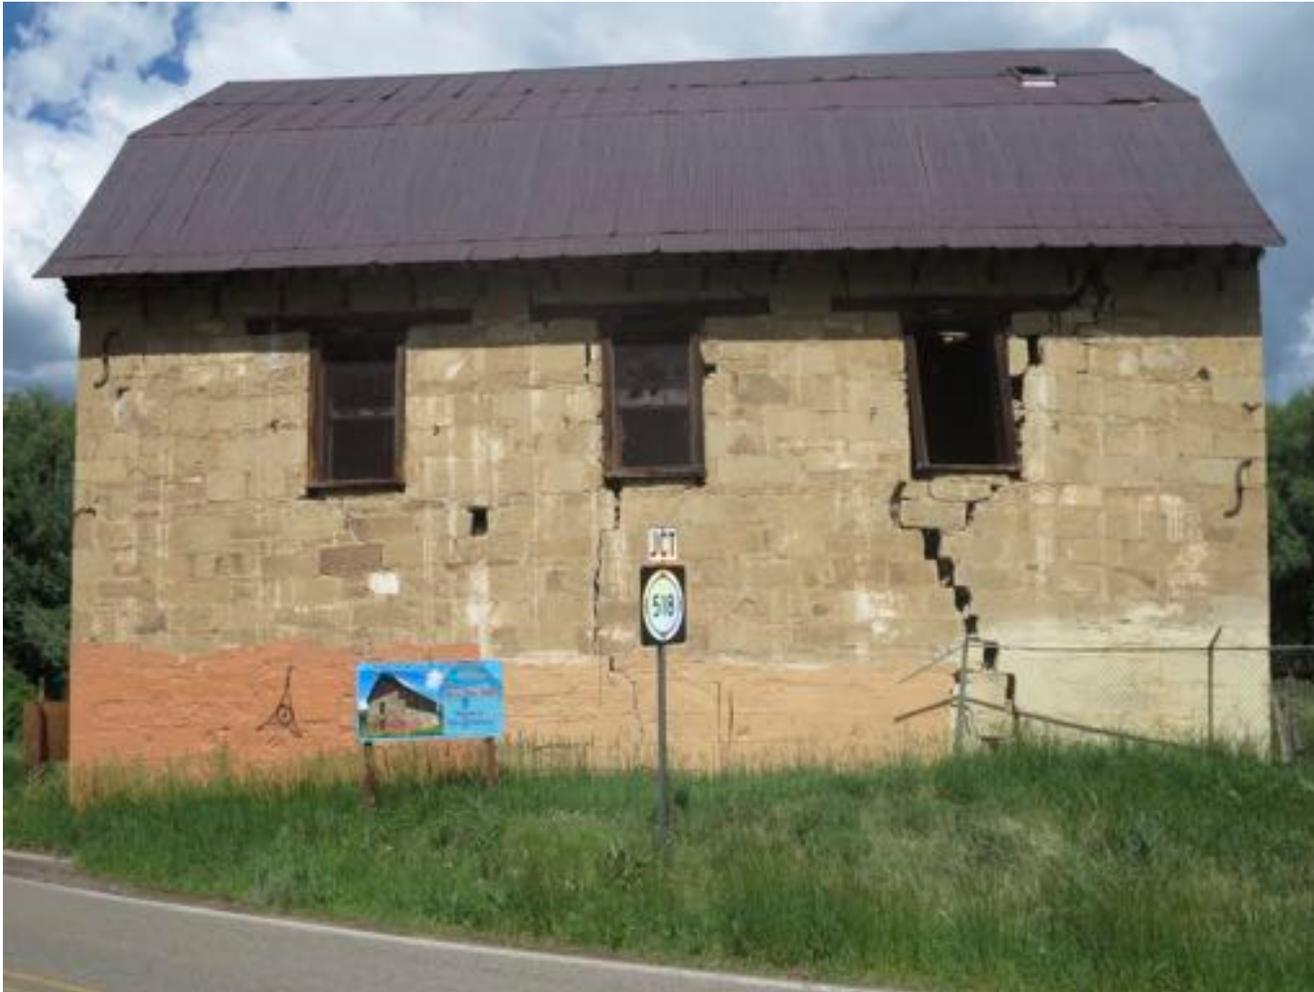
East façade showing major cracking. 9 June 2015

Subsequently, Engineering Analytics of Raton was contracted by the Foundation to prepare a report on options for stabilization of the north part of the walls. After considering various options for stabilization, Engineering Analytics recommended permeation and compaction grouting.

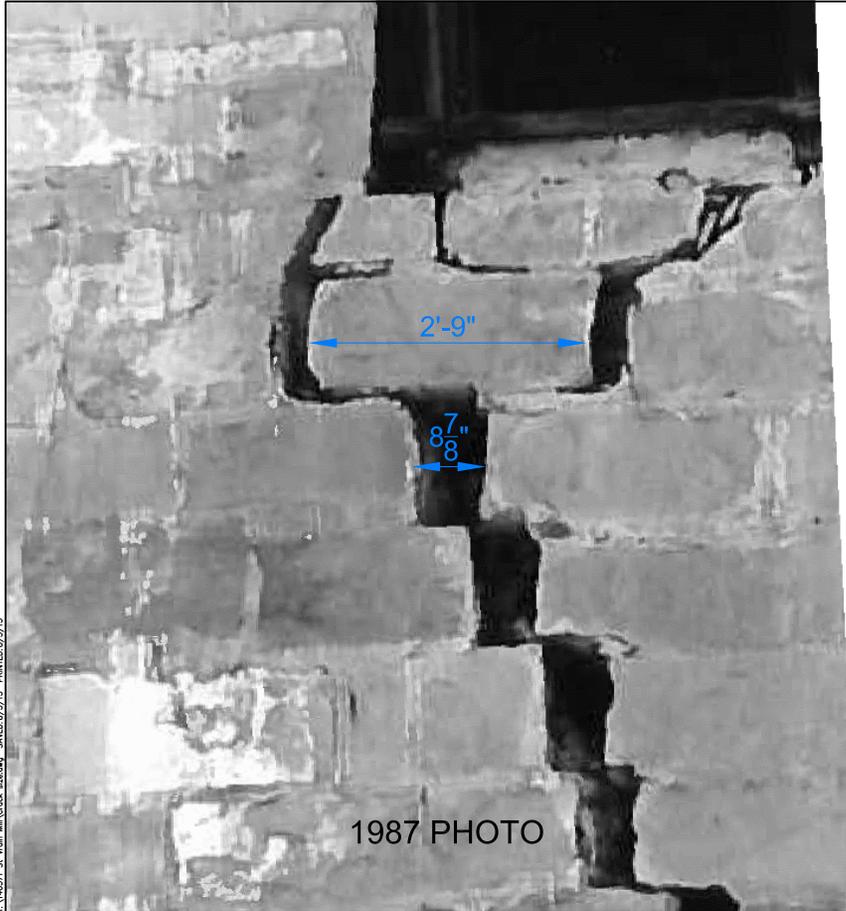
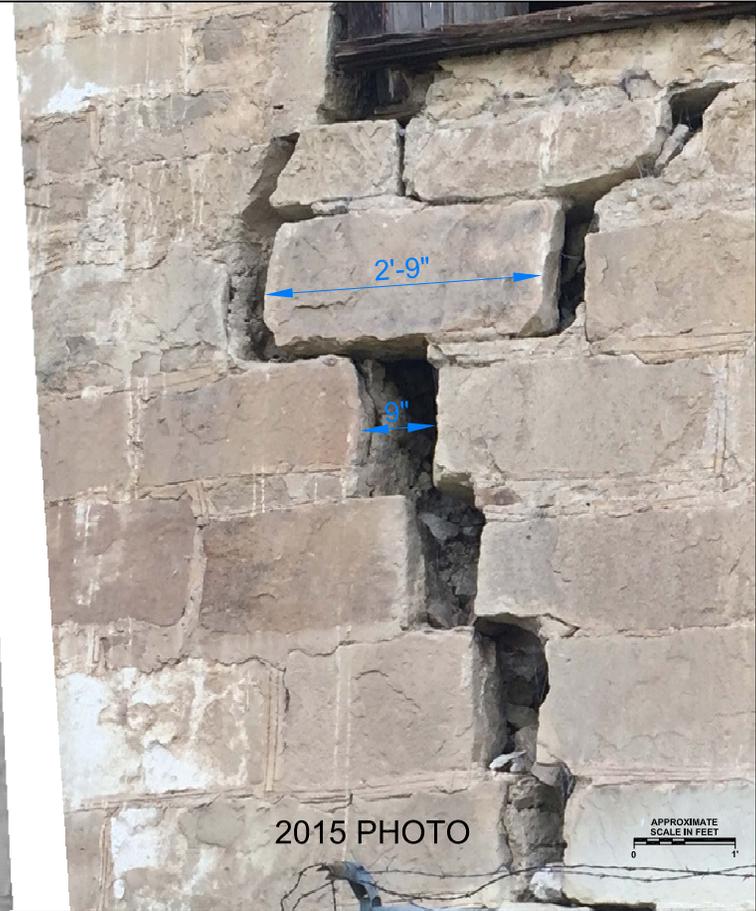
COMPARISON OF CRACK FROM 1987 TO 2015  
ST. VRAIN MILL

1987 PHOTO

2015 PHOTO

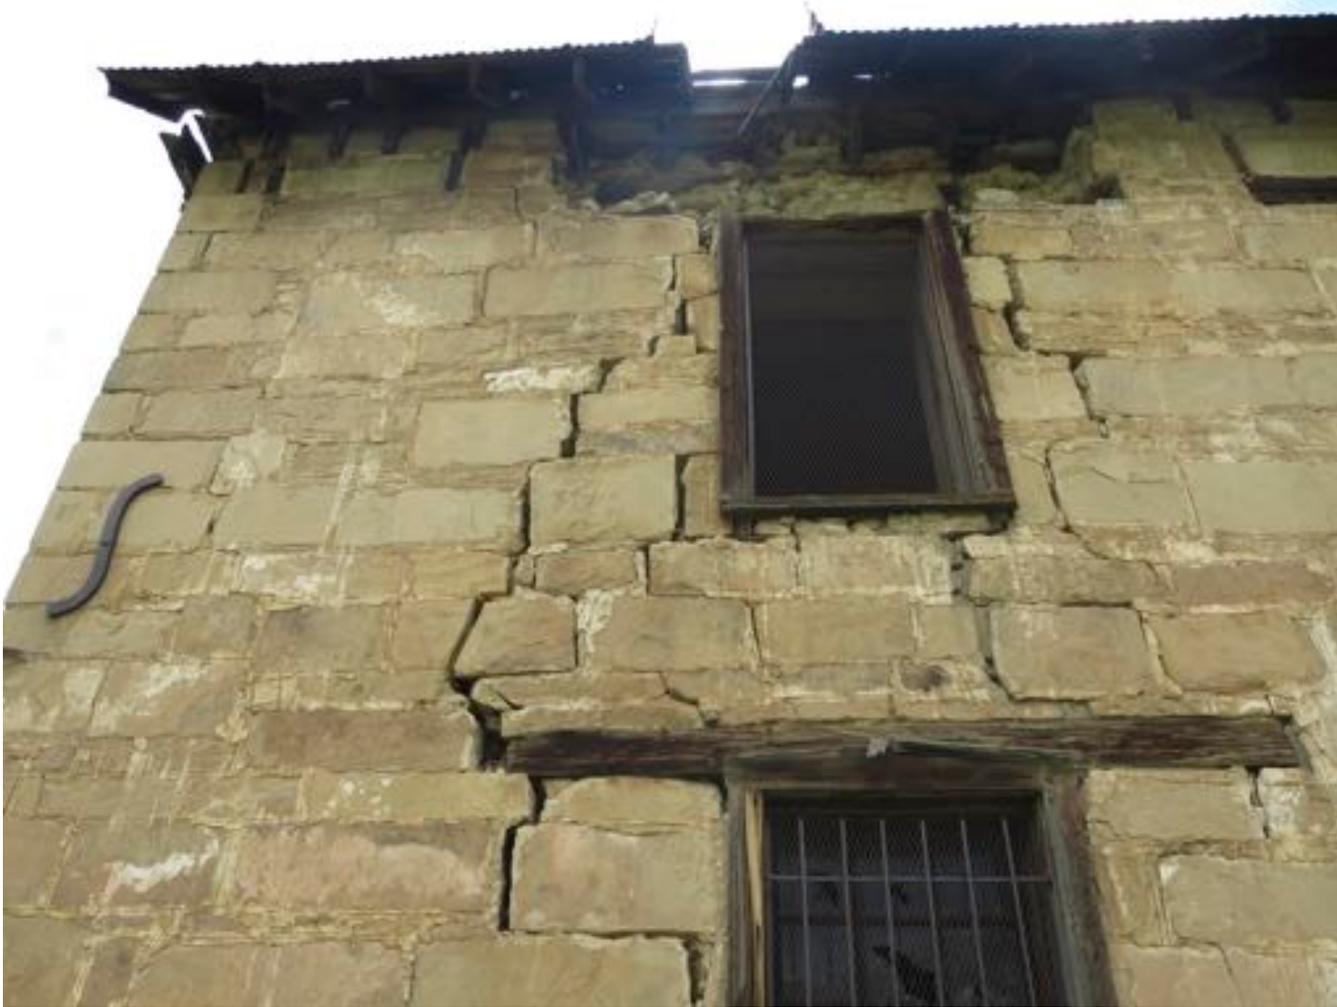
The section of stone masonry above the window in the northwest corner of the second floor has fallen off of the building due to the deteriorated lintel below. The stone masonry above the adjacent windows on the west wall of the second floor has significant cracks and some stones appear to be at risk of falling off of the wall.

Eave deterioration; cracking on stone wall on west façade near northwest corner. 9 June 2015

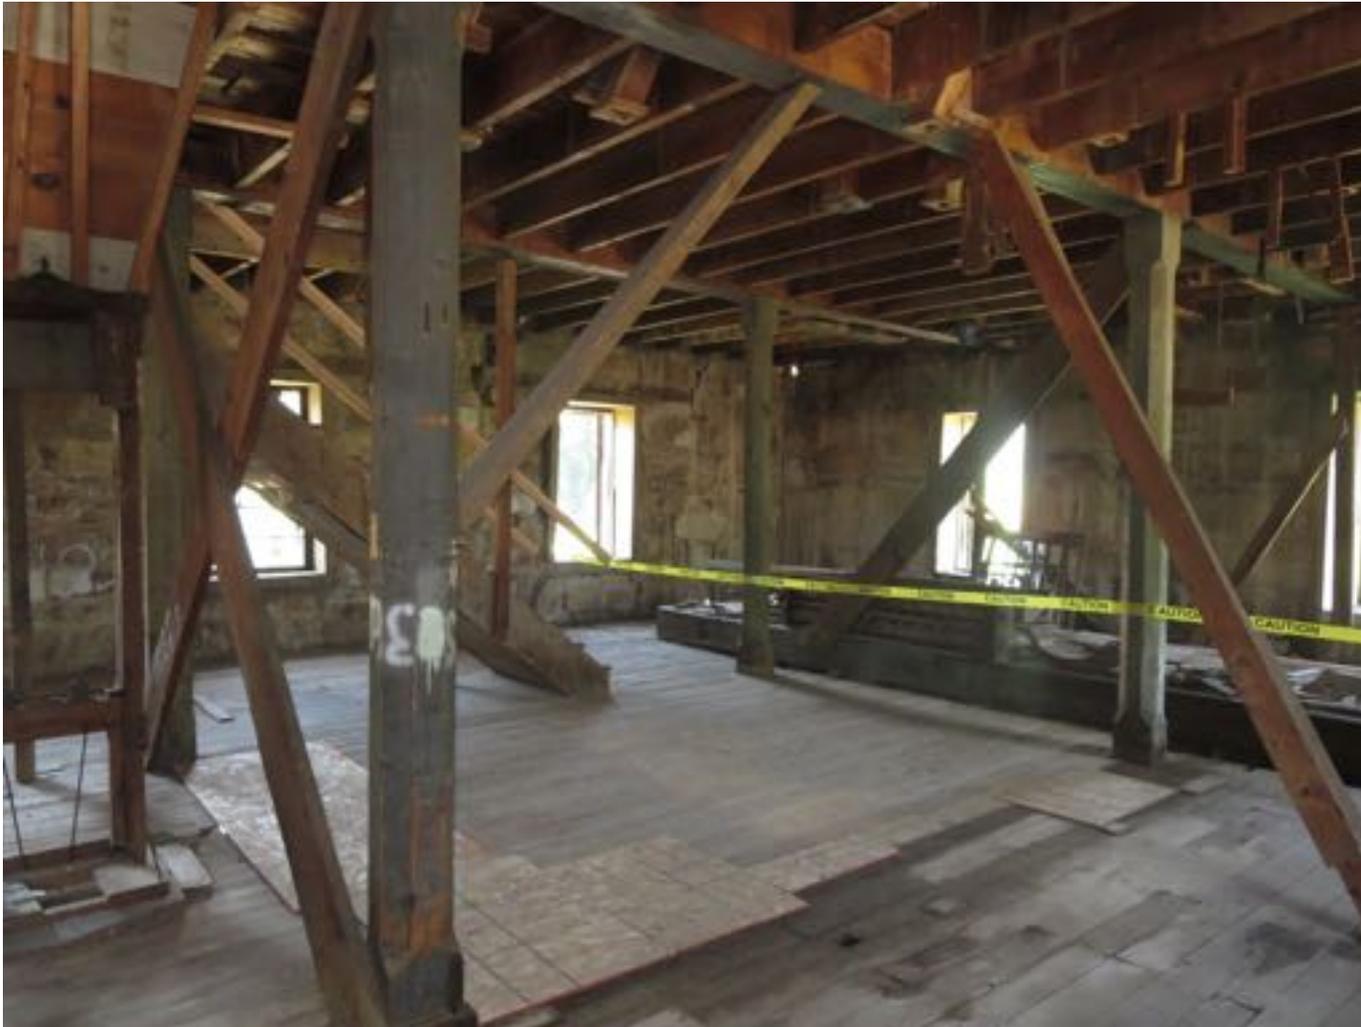
Second floor northwest corner showing oil stain on floor, raised platform, chutes. 30 June 2015

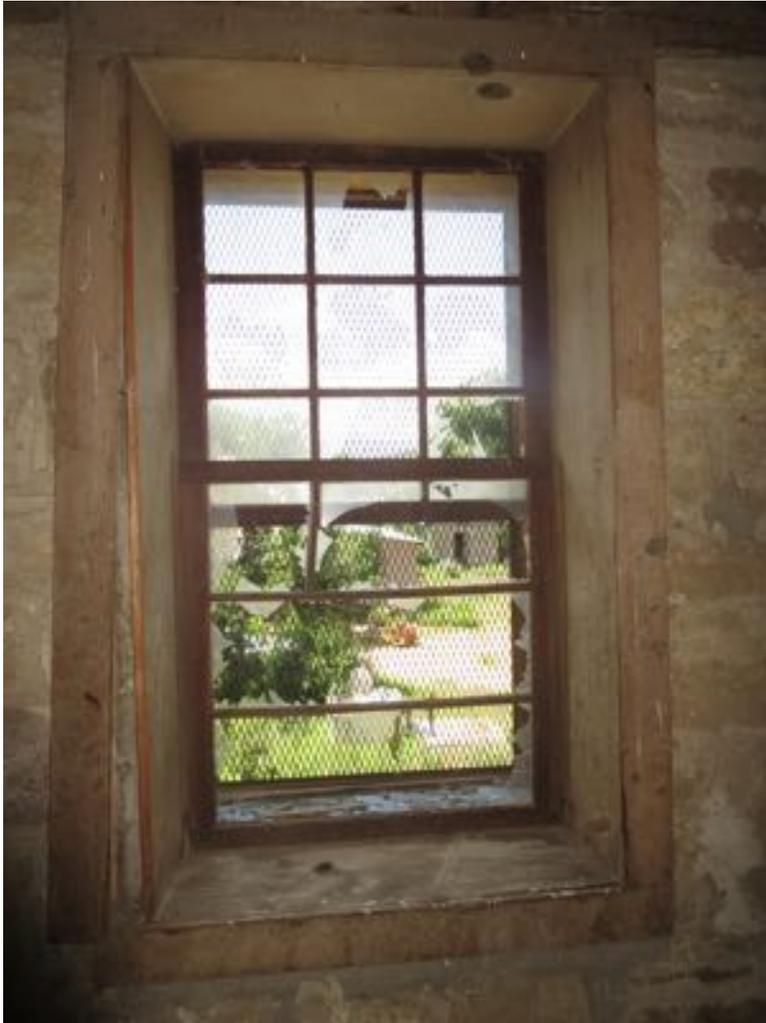
Typical first and second floor windows (second floor, west wall, center window). 9 June 2015

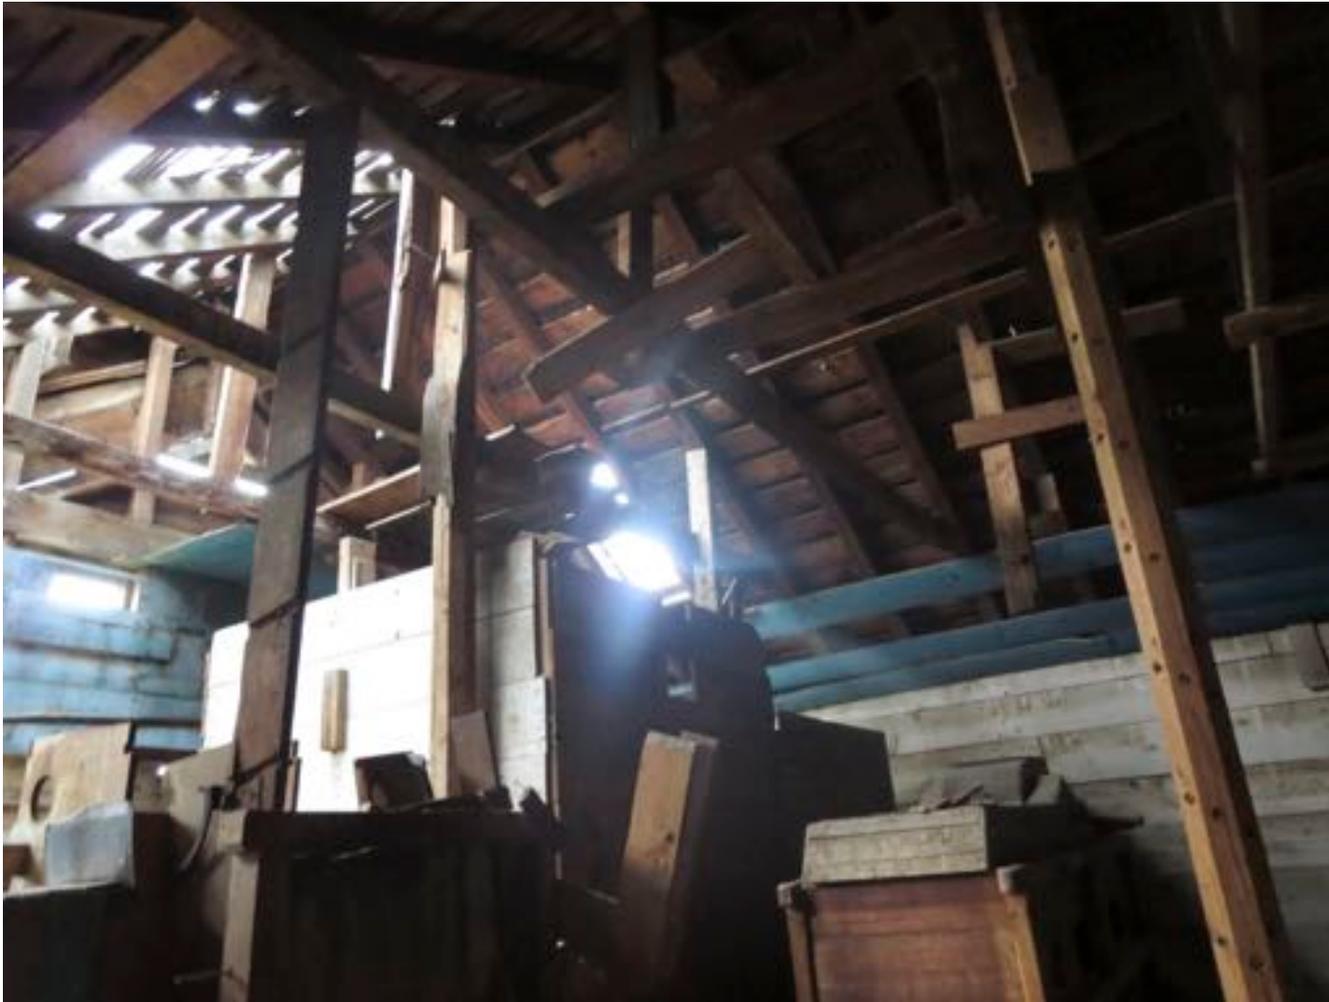
**6. Roof:** The corrugated steel roofing has a dark brown rusted finish and is attached to 1” thick roof deck planks running perpendicular to the rafters below. It is probable that the original roofing material was wood shingles. A large section of steel roofing is missing at the northwest end of the building. There are water stains on a number of the decking boards. There is some damage to the roof decking at the exposed northwest area of the roof where the steel roofing is no longer present.

Third floor north end showing missing roof, corner platform, and milling equipment. 9 June 2015

Although the original mill roof was probably cedar shingles, it seems best to reroof using corrugated steel. The exact age of the present corrugated steel roofing is unknown, but it is probably at least 90 years old. New 24 or 26 gauge corrugated steel can be applied to the roof and allowed to rust in place. There would be an awkward orangey stage but within about 2 years, the roof will weather to a matte dark orangey brown rusted color. Due to the roof overhangs, the rusty water initially coming off the roof will probably not seriously stain the stone walls below. Once the rusting is complete, the water will run clear. If properly applied, the roof will be virtually maintenance free for at least 50 years if not 100 years. It is recommended by NMHPD that after initial rusting is complete, the roof be treated with linseed oil to prevent further rusting.

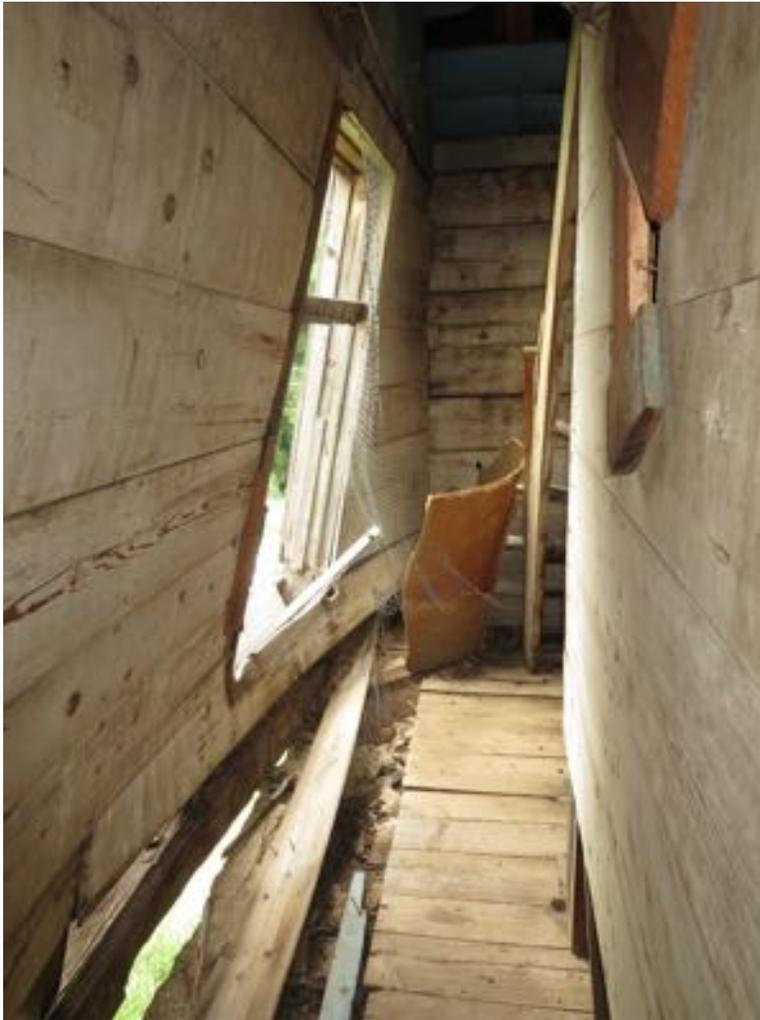
Third floor northeast corner showing bowed gable, exposed stone wall, hopper and ladder. 23 July 2015
